Report on Field Measurements and Assessment of the I-64 Kanawha River Bridge at Dunbar, West Virginia

Final Report

ATLSS Report No. 01-14

September 2001

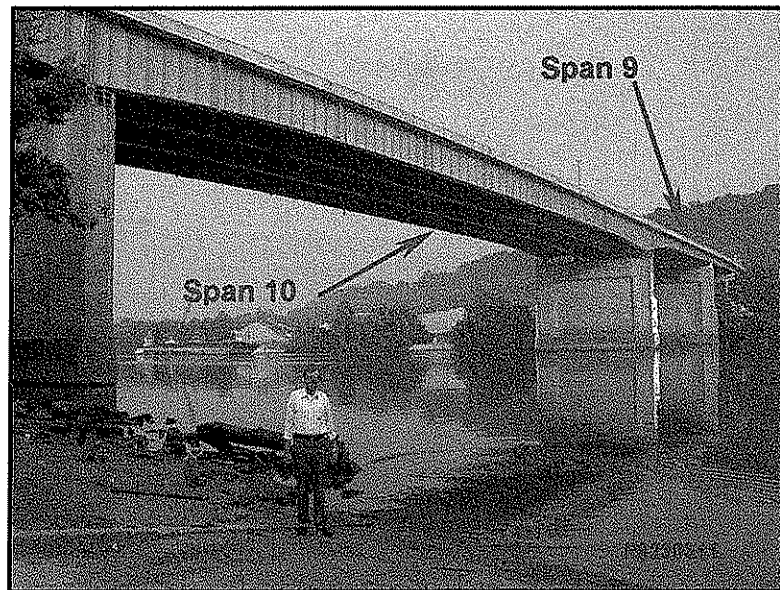
Figure 1.1 – Photograph of elevation view of upstream face of bridge

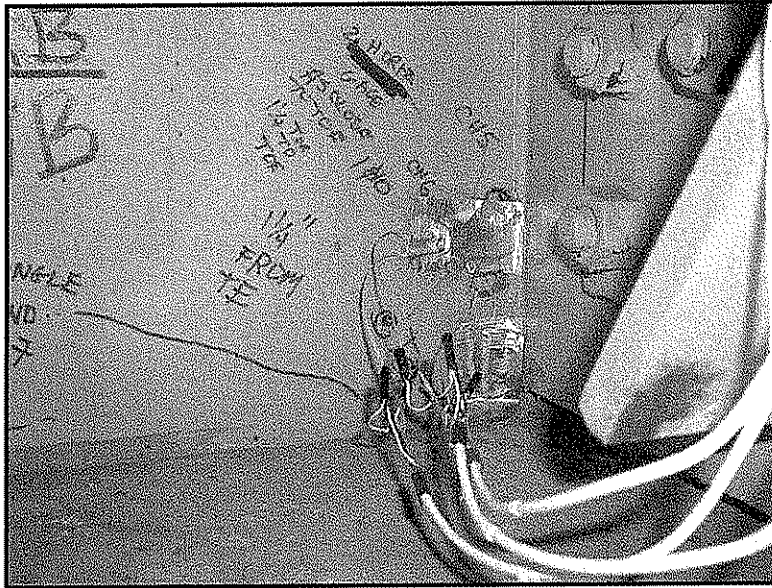
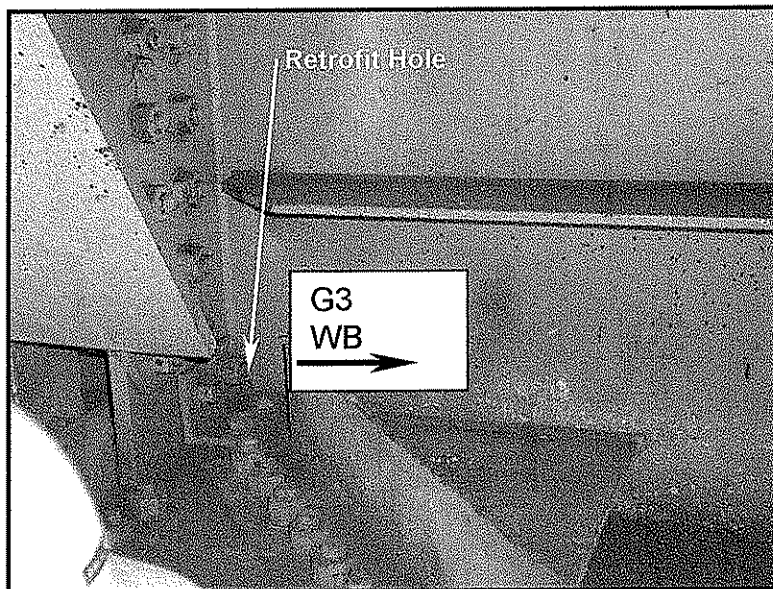
Figure 2.3a – South Face of Girder G3 at FB 37

Figure 2.3b – North Face of Girder G3 at FB 37

Figure 2.3a & 2.3b – Photograph of gage installation at retrofit holes at bottom gusset plate/web connection at G3 FB37
Gages were also placed at the bottom web gap.

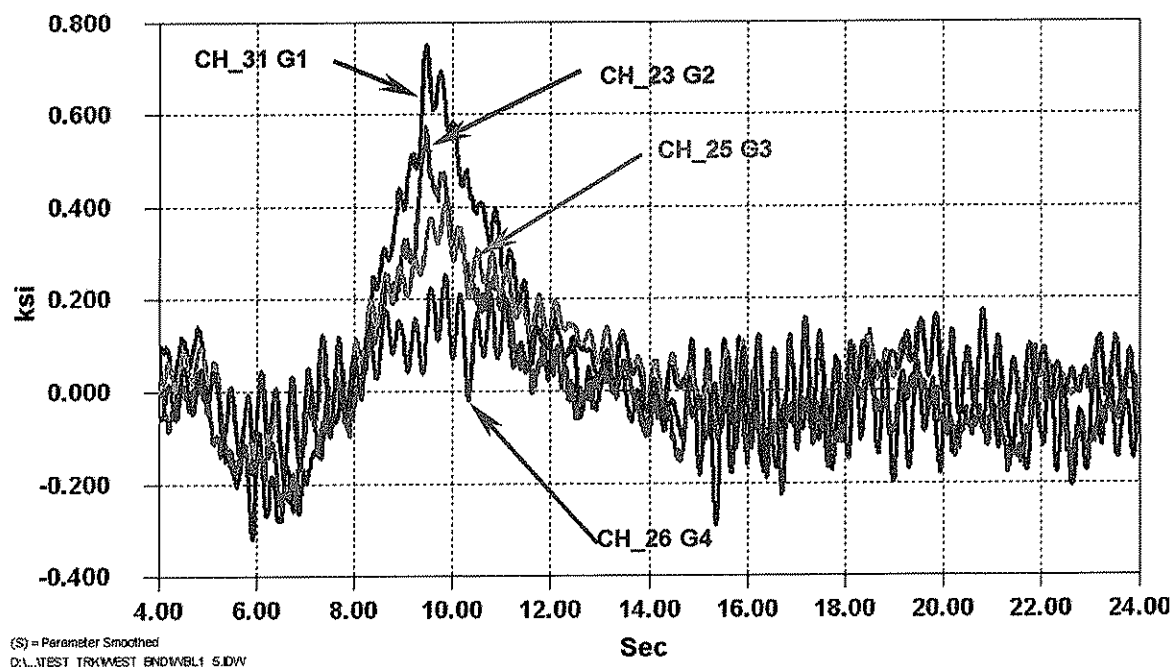
Figure 4.1 – Span 10 main girder bottom flange response near FB24 –
Test truck headed westbound in lane one (Test #15)

Figures 4.1 and 4.2 illustrate the response of each of the main girders at floorbeams FB24 and FB35 for gages mounted on the bottom flange for spans 10 and 11

respectively. During this test, the test truck was headed westbound in lane one. There were no other trucks in the immediate area (eastbound or westbound) during this test run. In this position, the truck is located between G1 and G2, but is slightly closer to G2. As expected, the greatest stress ranges are produced in girders G1 and G2 and less in girders G3 and G4.

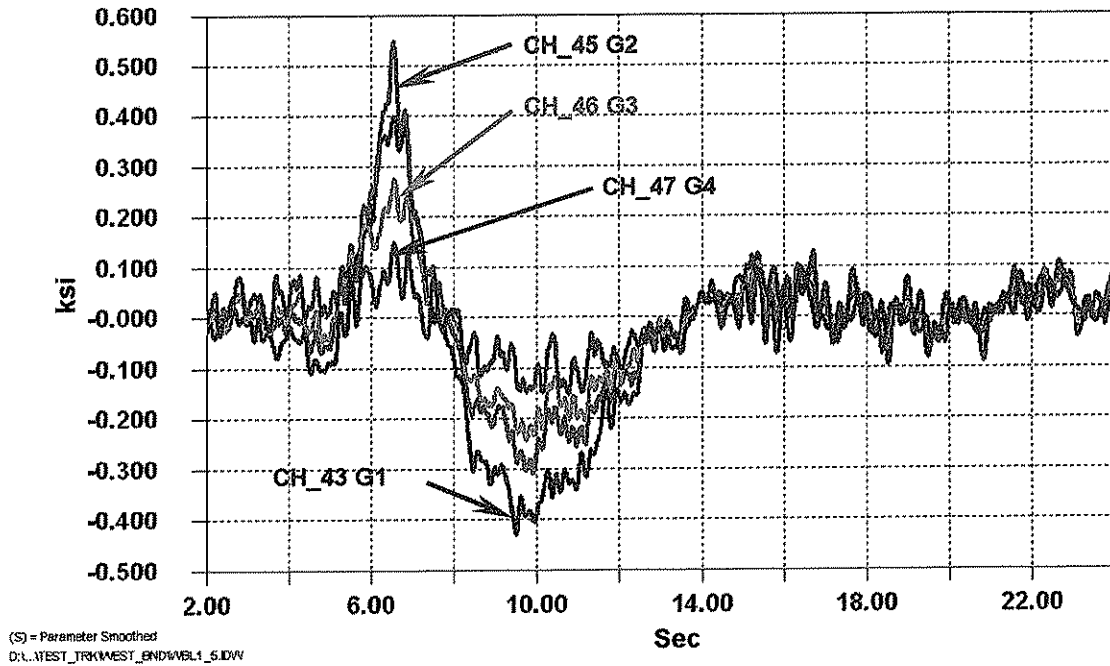
Figure 4.2 – Span 11 main girder bottom flange response near FB35 –
Test truck headed westbound in lane one (Test #15)

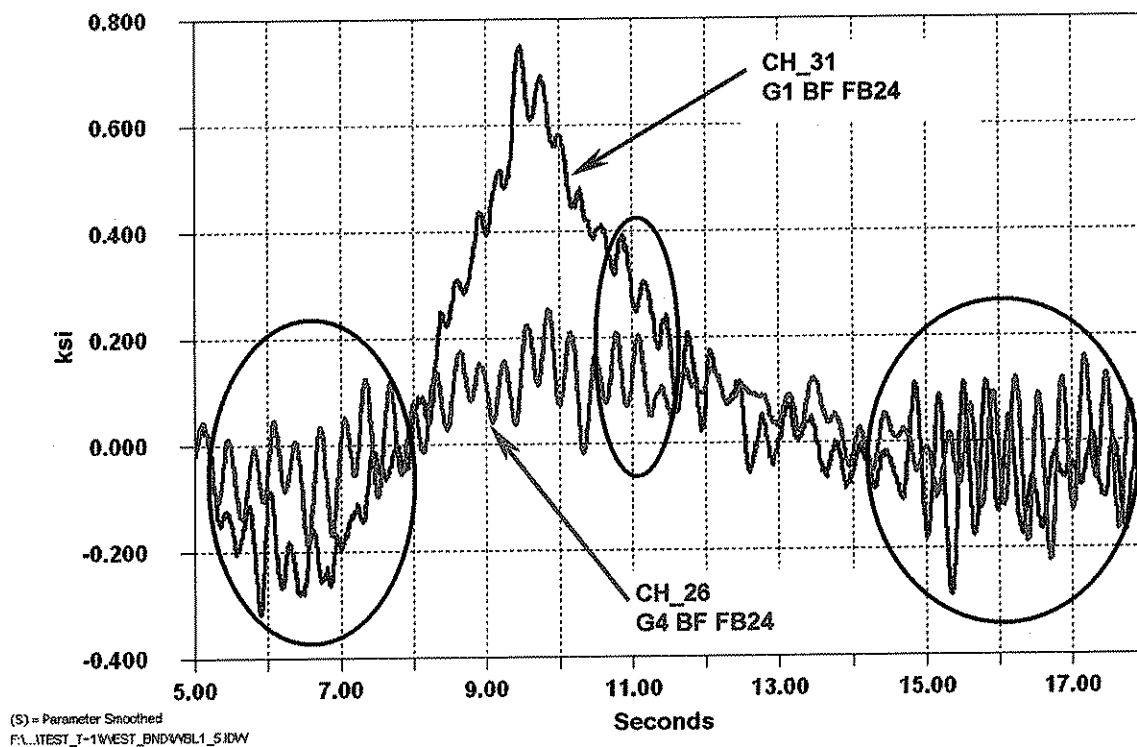
Figure 4.3 - Dynamic effects in girders G1 and G4 due to passage of test truck in lane 1

For girders not directly loaded during a particular test, the “static” stress range is small. However, the dynamic effects appear greater for these girders since the frequency response for all girders is approximately equal in the first mode. Figure 4.3 compares data from girders G1 and G4 at floorbeam FB24 for a test in which the test truck was traveling westbound in lane 1 near girder G1. As expected, the stress range is greatest in girder G1 and less in G4. However, the vibration response before, during and after the test truck passes is nearly equal for both girders at different times during the vehicle

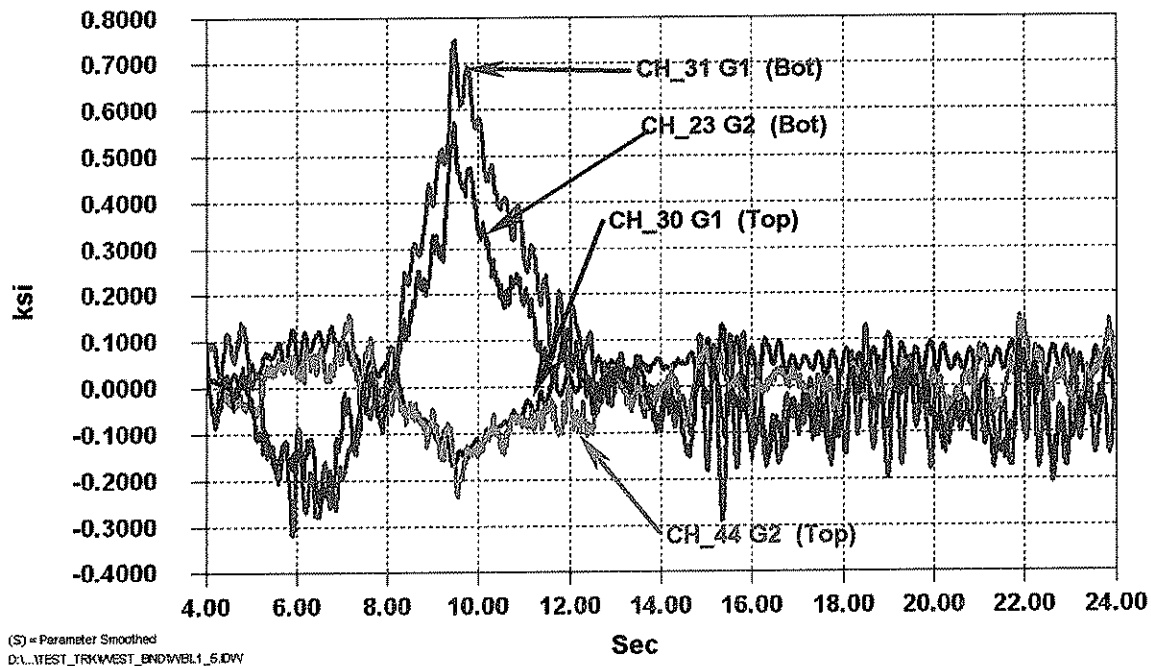
Figure 4.4 illustrates the response of the test truck passing in lane one, headed westbound for gages installed in span 10. (this is the same test shown in Figures 4.1 and 4.2). Note the low compressive stress produced in the top flanges. Although the girders were designed as non-composite, the measurements verify that a significant degree of composite action is being developed.

Figure 4.4 – Measured response as test truck passed in lane one, headed westbound
Note difference in stress range in top flange and bottom flange strain gages

A review of data collected during the controlled load tests and from on-site monitoring of traffic was made in order to estimate the location of the neutral axis. At floorbeam FB24, located in the center span (i.e., span 10), the depth of the web is 150 inches. Based on the measurements at this location, the neutral axis is between 30 and 35 inches below the bottom of the top flange. This places the neutral axis at roughly 80% of the depth of the web above the bottom flange. At floorbeam FB35, located in the end span (i.e., span 11), the girder begins to haunch "down" to the pier and the depth of the web is about 94 inches. At this location, the neutral axis was estimated from the measurements to be between 9 and 19 inches below the bottom of the top flange. Hence, at this floorbeam, the neutral axis is located at about 85% of the depth of the web above the bottom flange, similar to what was observed at floorbeam FB24.

The measurements indicate that a considerable level of composite action exists between the girders and the concrete deck, under all service loads. This results in lower stress ranges as compared to the non-composite design assumption. For a fatigue evaluation, analytical models should account for this composite action in order to avoid overly conservative estimates of remaining fatigue life. This is recognized in the AASHTO assessment procedure for fatigue damage [2]

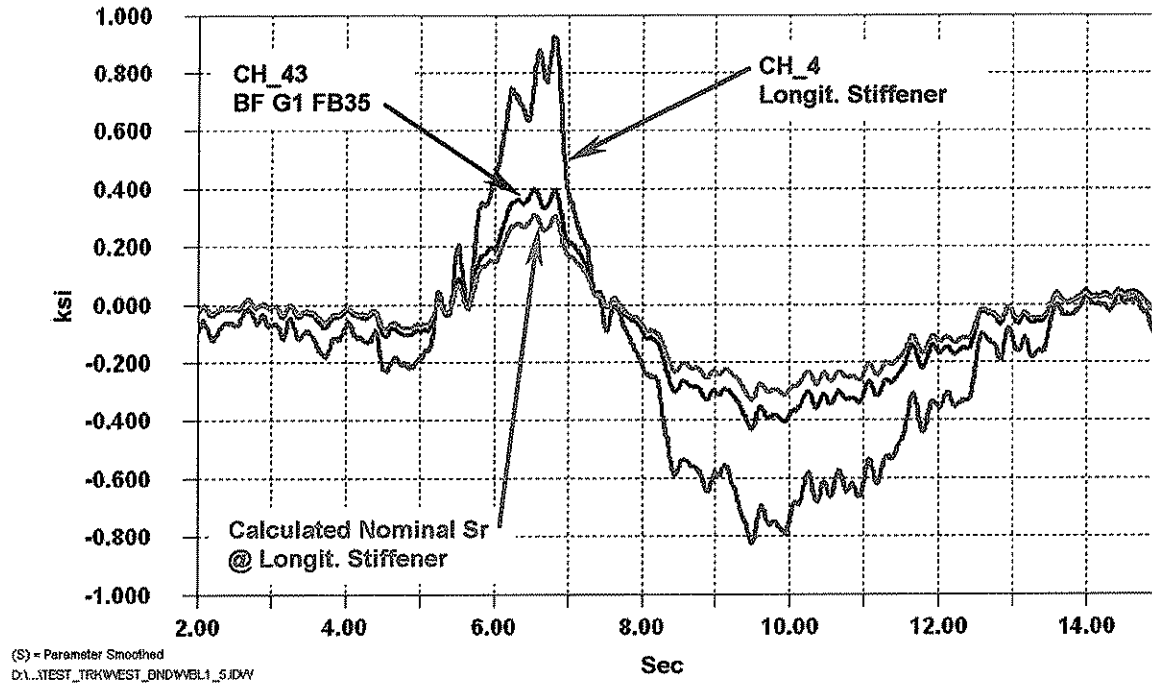
Figure 4.6 –Comparison of measured and calculated nominal in-plane stress range (S_r) at end of longitudinal stiffener at floorbeam 35 of girder G1

Data from channel CH_4, located at the end of the longitudinal stiffener at floorbeam FB35 and CH_43 located on the bottom flange of girder G1 at floorbeam FB35 are plotted in Figure 4.6. As can be seen, the stress range at the longitudinal stiffener (CH_4) is greater than at the bottom flange (CH_43). Also plotted in Figure 4.6 is the calculated in-plane nominal stress range in the web plate at the height of the stiffener, calculated using Eq. 4.1. The difference between the calculated and measured

Comparing the measurements at CH_4 and CH_43 indicate that the measurements at each location are roughly proportional. For noteworthy values of stress, the ratio between CH_4 and CH_43 was observed to vary between 2.5 to 3.0, as would be expected if out-of-plane stresses dominate the response at channel CH_4. *(It should be noted that the increase in stress at CH_4 {i.e., greater than the calculated nominal stress range} is also the result of a disturbance in the stress field at the end of the longitudinal stiffener.)*

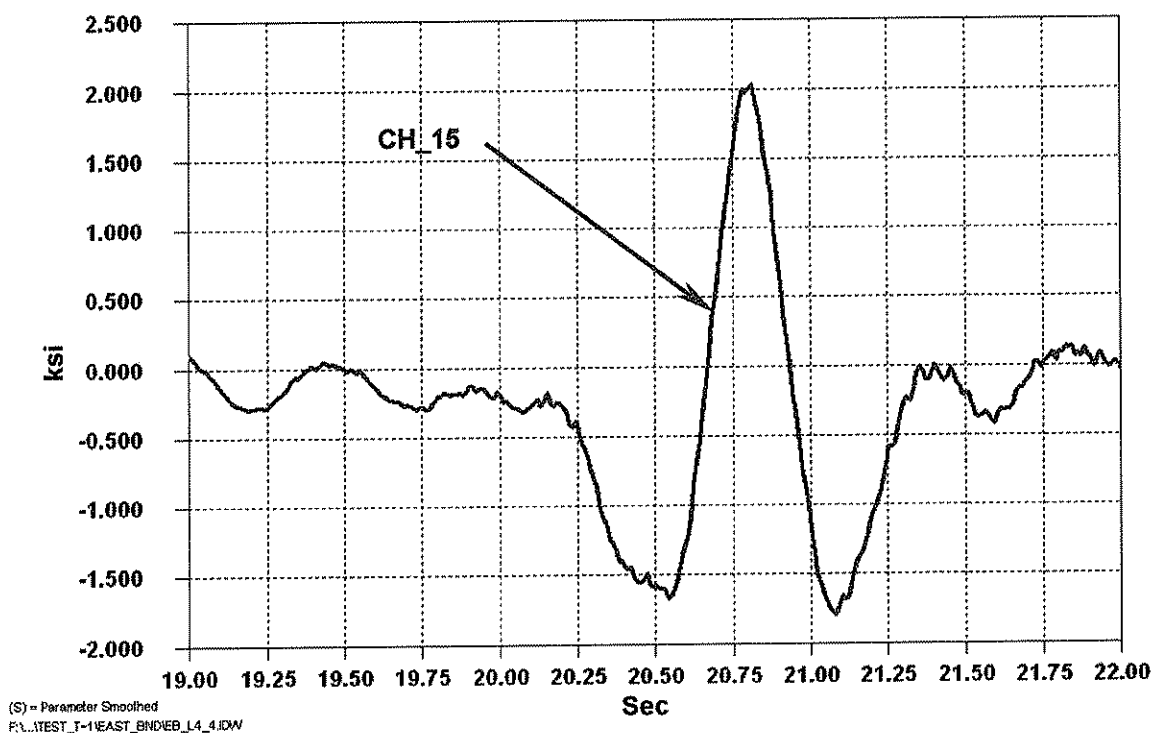
Figure 4.7 – Typical out-of-plane stress range at CH_15 located at bottom web gap on girder G4 FB 37 produced by test truck in lane four, Test #8. (Note stress reversal)

Figure 4.7 illustrates the response at channel CH_15 which was installed adjacent to the bottom web gap on G4 at FB37. This gage is oriented perpendicular to the longitudinal web/flange weld (i.e., vertically). The stress range produced by the test truck is about 3.9 ksi, with the test truck located in lane 4. A stress reversal occurs as the truck passes over the floorbeam. Larger stress reversals were observed at other gages as trucks passed in other lanes. For example, Figure 4.8 illustrates the response at channels CH_7 located at the bottom web gap on girder G3 at floorbeam 37. Note the stress reversal which occurs as random trucks cross the bridge during the on-site monitoring.

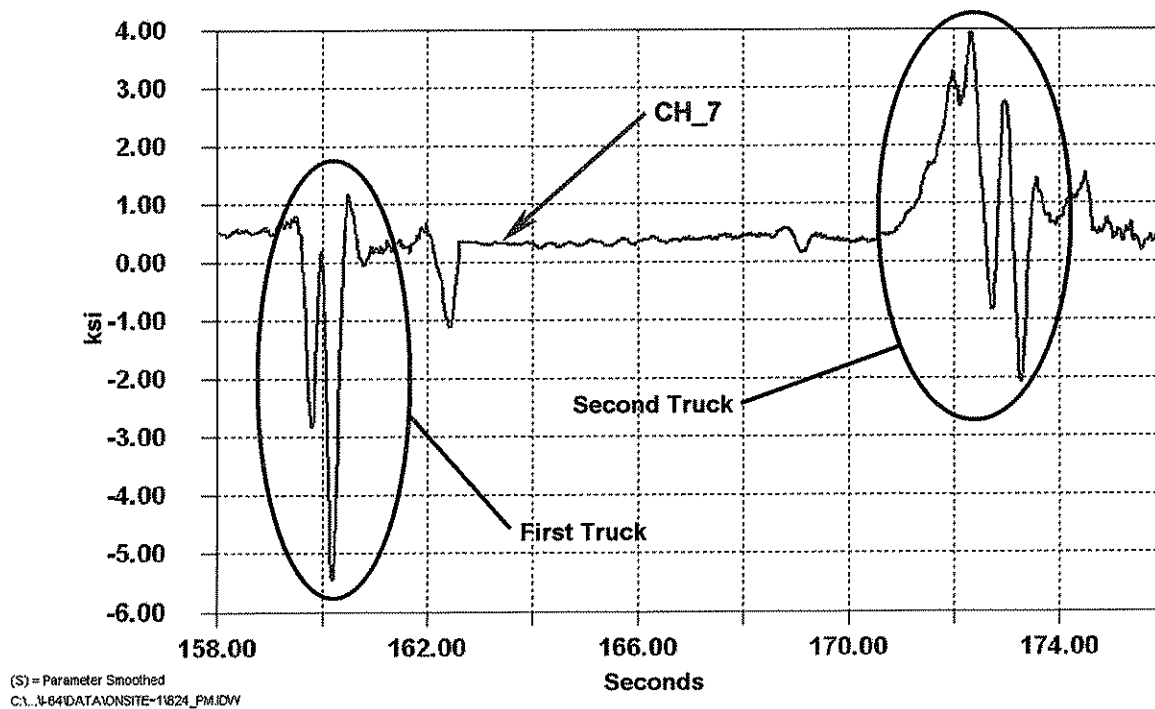
Figure 4.8 - Out-of-plane stress range at CH_7 and CH_13 located at bottom web gap on girder G3 FB 37 produced by random trucks – Note reversal in stress

The *individual* stress range for each of the events shown in Figure 4.8 is about 6.6 ksi and 6.0 ksi for the first and second trucks, respectively. Using the rainflow cycle counting method, the largest peak and valley of different stress ranges are combined to produce the maximum stress range of 9.4 ksi, (-5.4 ksi to 4.0 ksi) for these two events. Thus, the maximum stress range is not necessarily produced by an individual truck. The alternating effects of different trucks in different lanes will almost always produce the largest stress range at these types of details. *(For a full discussion describing the rainflow cycle counting method and its use related to the Kanawha River Bridge, see Section 6.)*

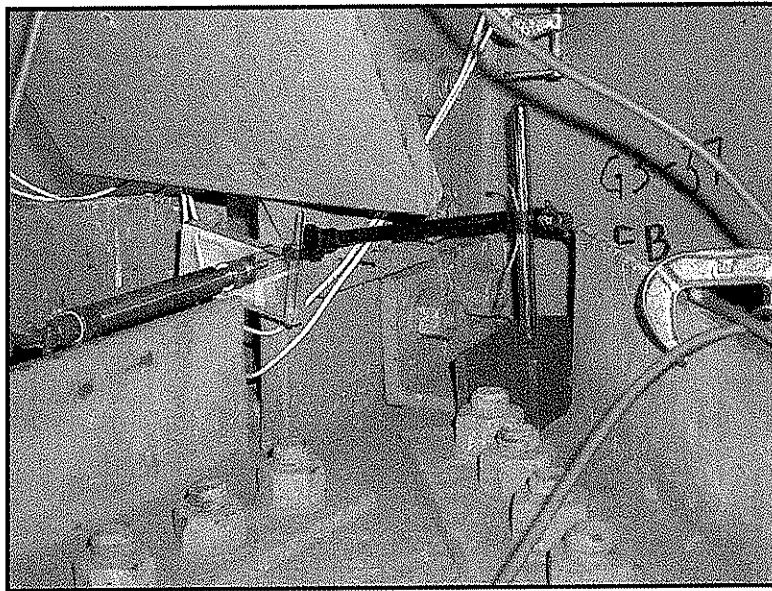
Figure 4.11 - Photograph of displacement sensor (LVDT) used to measure relative displacement between the gusset plate and the transverse connection plate at floorbeam FB37 on G3

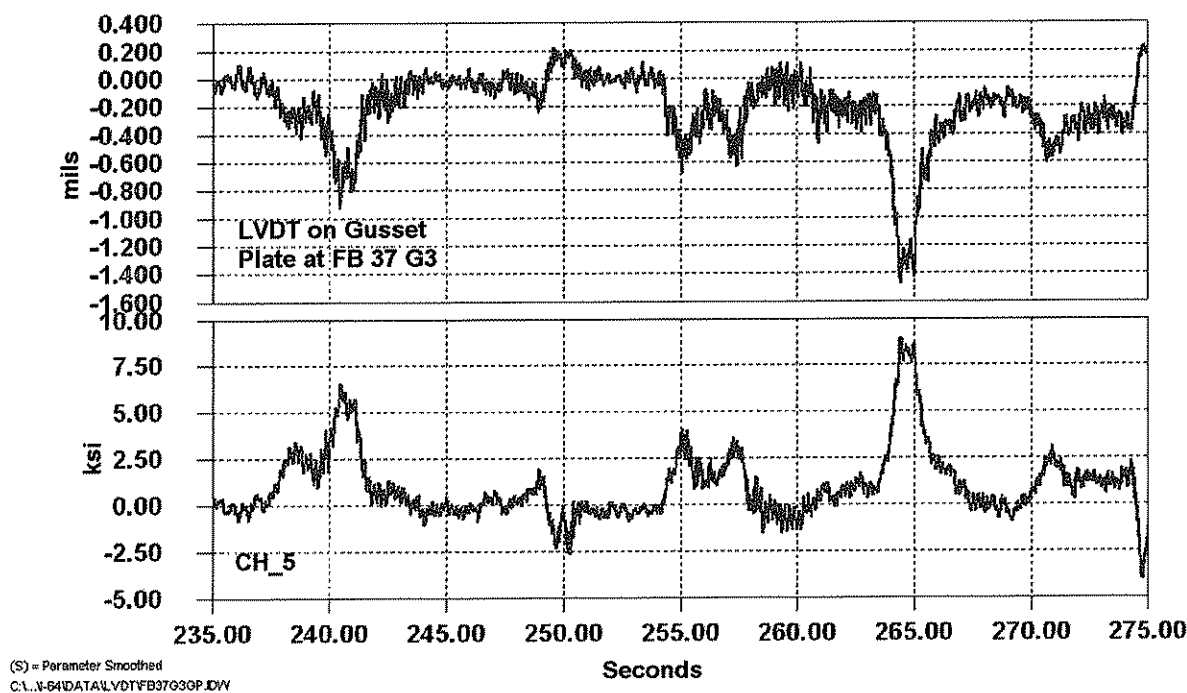
Figure 4.12 compares the displacement response as a random truck crossed the bridge along with stresses measured at channel CH_5. For the data shown in Figure 4.12, the gusset plate moved away from the transverse connection plate as trucks passed. The response at channel CH_5, which is located on the opposite side of the web, is also plotted in Figure 4.12. As can be seen, tensile stresses develop at channel CH_5. Considering the location of channel CH_5, this affirms that the web plate is bending in the direction indicated by the LVDT. Other gages at this location (e.g., CH_6, CH_8, & CH_9), suggest that web is also subjected to a moderate “twisting” about the transverse connection plate. The twisting is the result of forces being applied by the lateral braces which frame into the connection at angles. Such behavior is typical in bridges with lateral bracing similar to the Kanawha River Bridge.

As shown in Table 4.4, the maximum out-of-plane displacement measured during the on-site monitoring was about 1.6 mils which corresponded to a stress range of 9.9 ksi at channel CH_5. This magnitude of displacement indicates that the retrofit angles are not fully effective in preventing relative movement between the two components. The retrofit used at this location is not as effective as the pairs of larger angles installed at the upper ends of the transverse connection plates.

Figure 4.12 - Comparison of relative displacement measured between the gusset plate and the transverse connection plate at floorbeam FB37 on G3 and strain gage CH_5

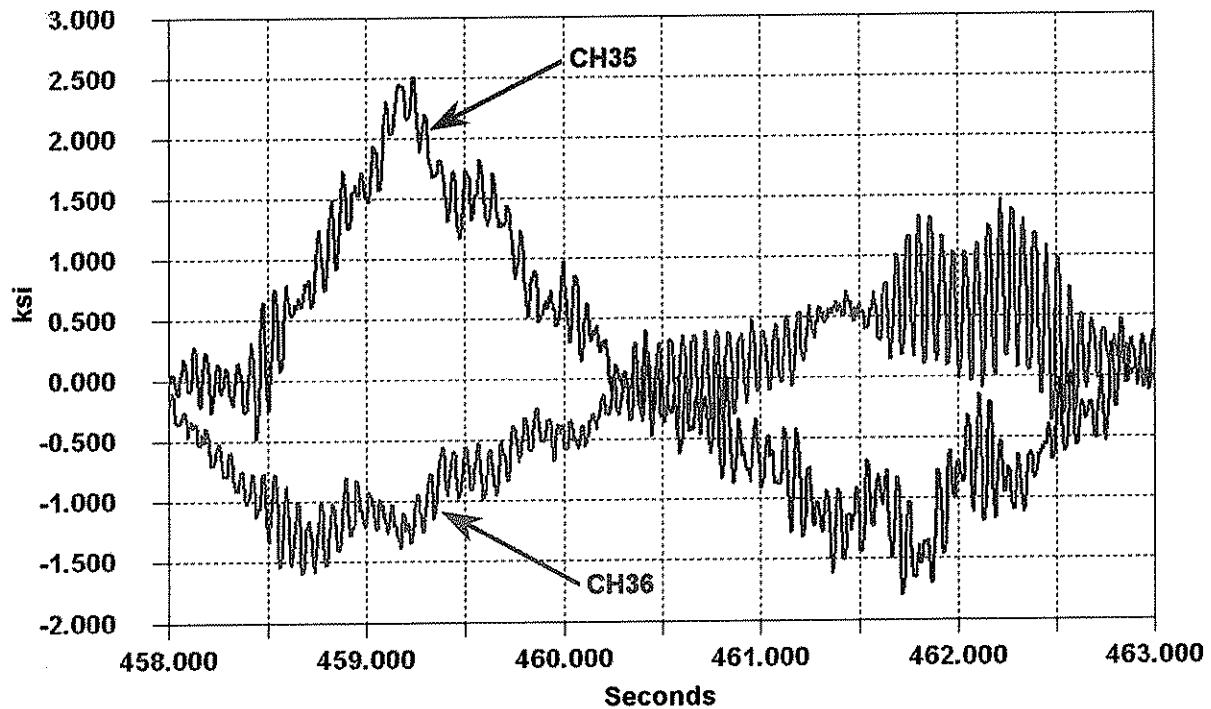
During the controlled load tests and the on-site monitoring, the maximum stress range measured in channel CH_35 and CH_36 was 6.3 ksi and 4.0 ksi, respectively. A typical response from channels CH_35 and CH_36 are presented in Figure 4.18. The data were collected as a random truck crossed the bridge in lane four headed eastbound. Note that there is a sinusoidal vibration between 15Hz to 18Hz that occurs throughout the time history. It is apparent from Figure 4.18 that the vibration increases the maximum stress range due to the crossing vehicle by about 0.8 ksi. The larger “free” vibration induced stress is introduced after the vehicle crosses from span 10 into span 11. (*This was observed at several lateral members and gusset plates on the bridge. The maximum stress range associated with this vibration was about 1.5 ksi at FB34.*)

For weld toe cracking, the fatigue resistance of this detail can be categorized as category C for the cruciform type joint. The CAFL for category C is 10.0 ksi, which is

greater than the maximum stress range measured at this detail at floorbeam 34 on G2. It is unlikely that the other similar details in bay 2 (i.e., at floorbeams 27-30, 32, 33, and 35 near pier 10 and corresponding floorbeams near pier 9) are subjected to stresses much greater than measured at floorbeam FB34. Hence, weld toe cracking is not expected to occur at this type of detail during the remaining life of the structure.

Figure 4.18 - Typical response from CH_35 and CH_36 at FB34 during the passage of a random truck headed eastbound during the on-site monitoring
Note vibration of 15Hz to 18Hz, particularly at channel CH_35

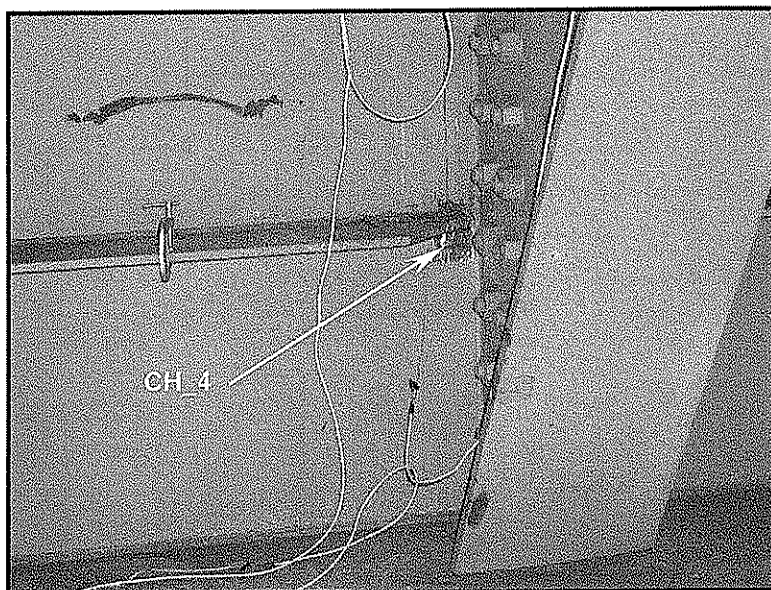
Channel CH_4, on girder G1 at floorbeam FB35 was included in the long-term monitoring program. Channel CH_4 was installed on girder G1 at floorbeam FB35 (See Sheet 8 in Appendix A) adjacent to the longitudinal stiffener weld toe as shown in Figure 5.3. Table 5.5 summarizes the results of the measurements made during the long-term monitoring program. The fatigue resistance of this detail to in-plane stresses can be categorized as a category E detail. The constant amplitude fatigue limit (CAFL) for category E is 4.5 ksi.

Figure 5.3 – Photograph of strain gage CH_4 installed at the web gap of a longitudinal stiffener at floorbeam FB35 at girder G1

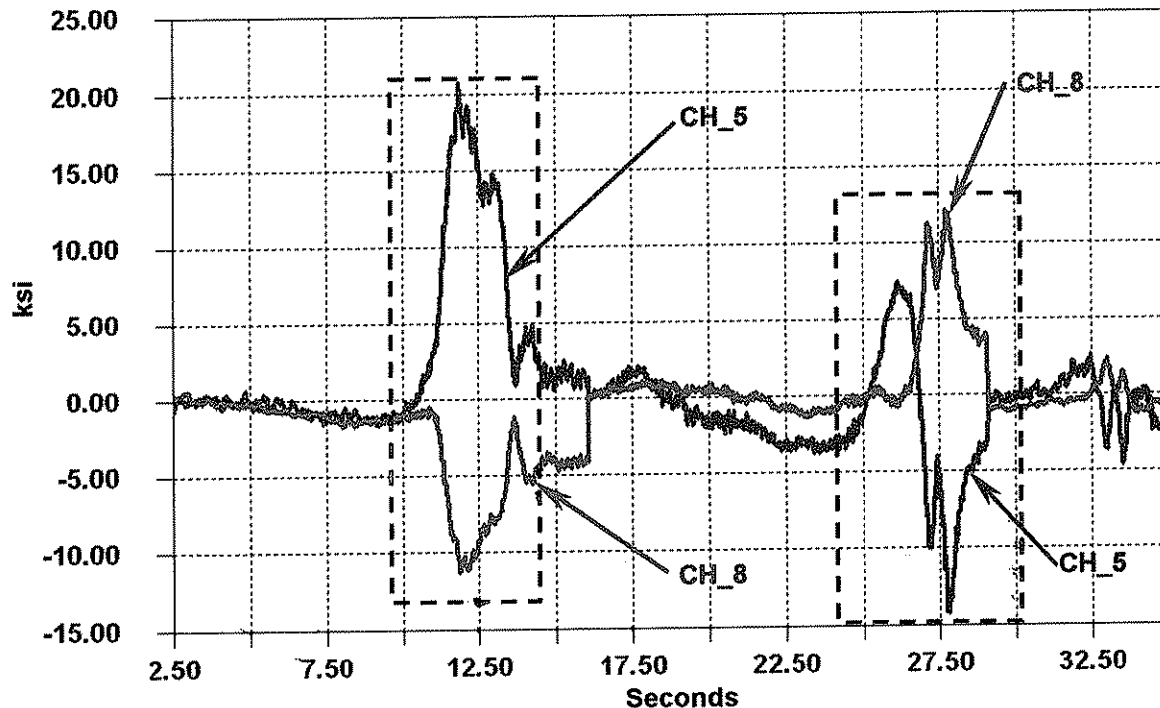
During the controlled load testing and on-site monitoring, high stress ranges were also measured at these locations. As expected, larger stress ranges were observed during the remote long-term monitoring program. Figure 5.4 presents a typical triggered time history for channels CH_5 and CH_8 recorded in late October, 2000. The two events presented (outlined in dashed boxes) were produced by different trucks and occurred about one hour and twenty minutes apart. As can be seen, a considerable stress reversal occurs.

The test results demonstrate that the two small retrofit angles installed in 1989 do not provide enough rigidity between the gusset and transverse connection plate to prevent high web gap cyclic stresses.

Figure 5.4 - Measured response at channel CH_5 and CH_8 installed on opposite side of gusset plate web gap at floorbeam FB37, girder G3. Note reversal in stress.

Using the rainflow cycle counting method, the maximum peak and minimum valley of different cycles are added to calculate the peak stress range. For the data shown in Figure 5.4, this results in a stress range of about 34.8 ksi and 23.4 ksi for channels CH_5 and CH_8, respectively.

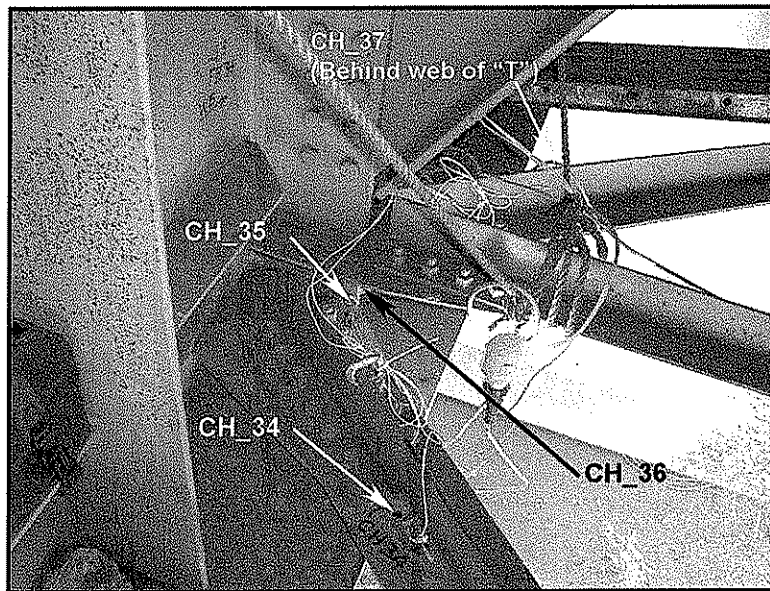
Uniaxial strain gages were also installed at floorbeam FB 34 of Girder G3 on the gusset plate and lateral braces (See Sheet 4 in Appendix A). Three gages, CH_34, CH_35, and CH_36 were included in the long-term monitoring program (See Figures 5.8 and Figure 4.17). Cracks have been reported at the ends of the gusset plate near the free edge of the transverse connection plate (i.e., near channels CH_35 and CH_36) [3]. These measurements are summarized in Table 5.8.

Figure 5.8 – Photograph of gages installed on gusset plate and lateral members at floorbeam FB 34 of Girder G3

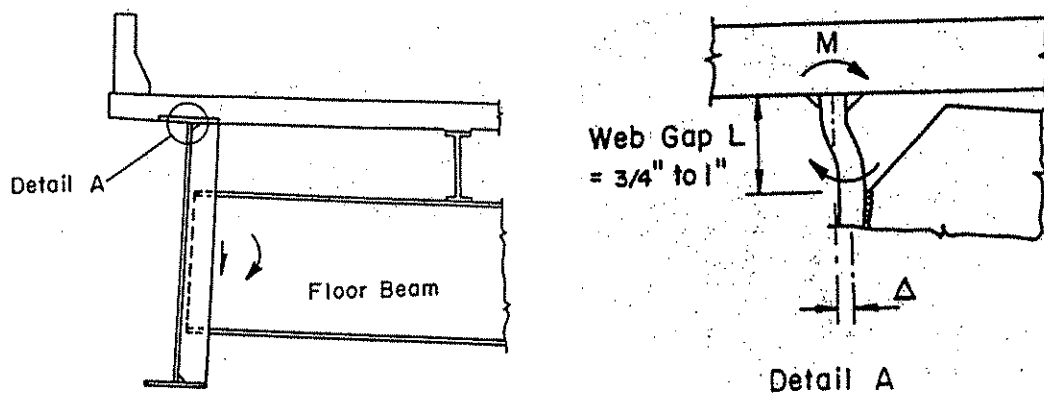
At some locations, one of the gusset plates is welded to both the web and the transverse connection plate. However, the transverse connection plate is not attached to the flange. As a result, cracking can occur due to out-of-plane displacements within the bottom web gap region as shown in Figure 6.3. (Although Figure 6.3 illustrates this condition at a top flange, the behavior is similar at the bottom flange.) Laboratory and field testing programs have demonstrated that cracking typically occurs at the toe of the fillet weld connecting the web to the flange or at the web to the transverse connection plate [9,10,13]. The fatigue resistance of this detail, subjected to an out-of-plane stress range, can be characterized using the S-N curve for category C [10]. Category C has a constant amplitude fatigue limit (CAFL) of 10ksi

Figure 6.3 - Web gap distortion due to out-of-plane displacements
At top flange (bottom flange similar)

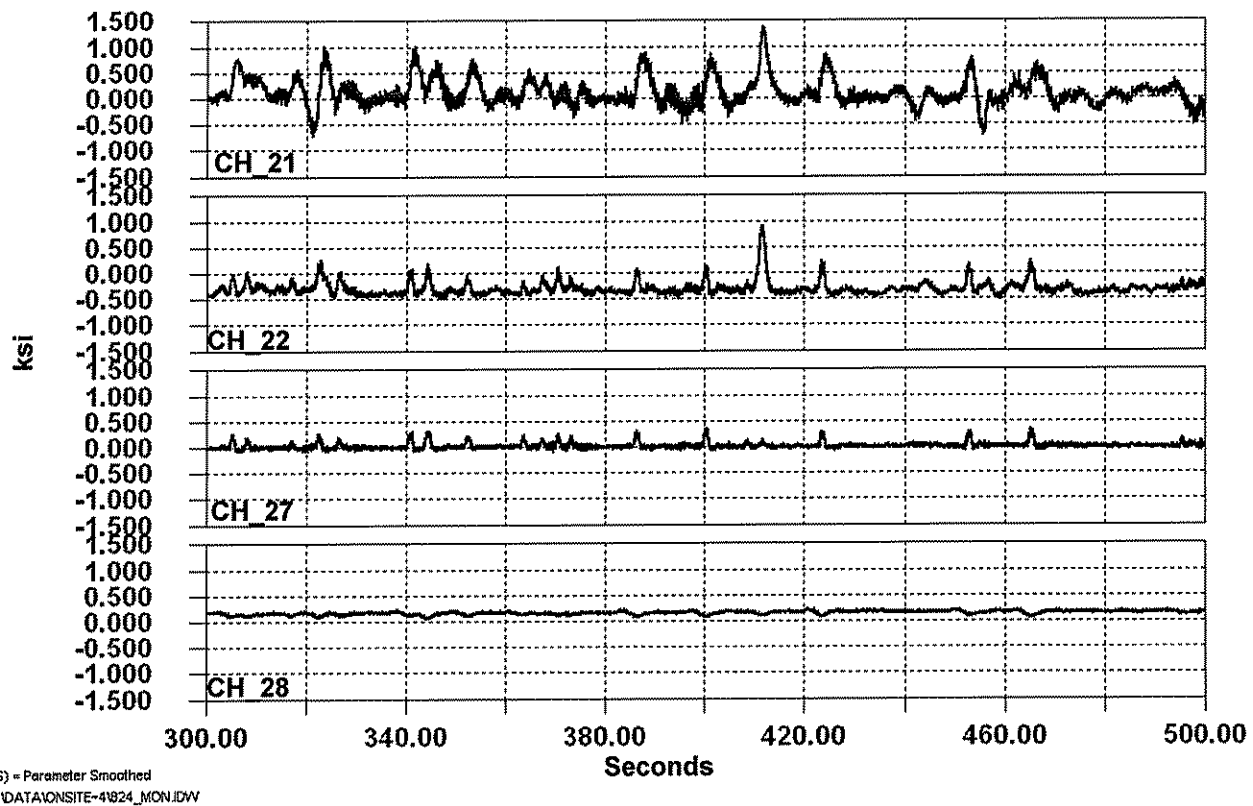
In order to better understand the behavior at this cross frame, concurrent time history data from channels CH_28 & CH_27, at girder G1 and channels CH_22 & CH_21 at girder G2 were reviewed. Figure 6.4 presents the typical response at these gages during the passage of a random truck. It is clear that the greatest stresses occur in gages installed adjacent to girder G2. At first glance, this appears inconsistent, especially for channels CH_22 and CH_27 which are located on different ends of the same member. However, further review of the structural system and force path shed some light on the measured behavior. Figure 6.5 illustrates the force distribution for a given load condition assuming simple statics and truss theory. According to basic truss theory, the portion of the lower strut enclosed in the dashed box must be a zero force member. Forces can only be carried through the deck and through the connection of girder G2 to girder G3 through the lateral system and cross frame in bay 2. However, due to some inherent stiffness

provided by the girder web, a small force can be carried through this end of the angle, as evidenced by the small stresses measured in channel CH_27 and CH_28.

Figure 6.4 - Comparison of response e at channels CH_21, CH_22, CH_27 and CH_28

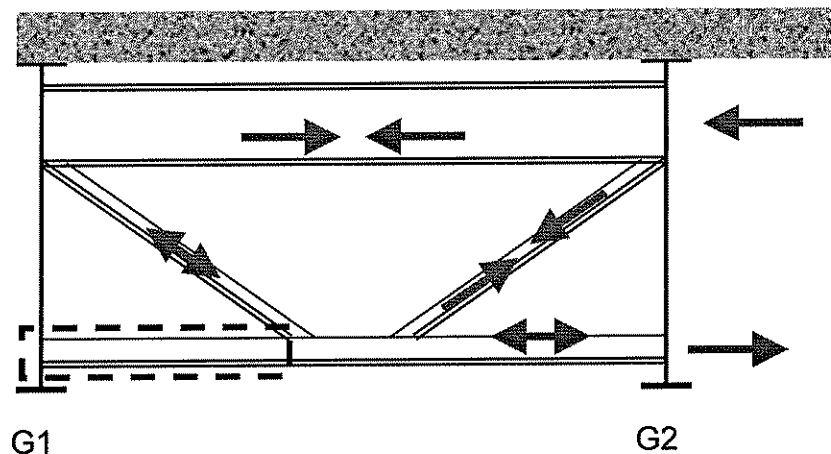
Figure 6.5 - Force transfer in cross frames in bay one or three
(Bay one shown, bay three opposite hand)

The lateral strut is a WT 5 x 16.5 and has an area of 4.85 in². The stress at channel CH 27 was between 0.5 and 0.75 ksi during the on-site monitoring. Although the magnitude of stress is relatively low, the force in the member (assuming axial stress) could be as high as 3.6 kips. Recall that web gap cracking is the result of out-of-plane displacements. Since there are no members on the outside of girder G1, all restraint is provided by the out-of-plane stiffness of the web. Hence, the connection is very flexible when subjected to even small out-of-plane forces.

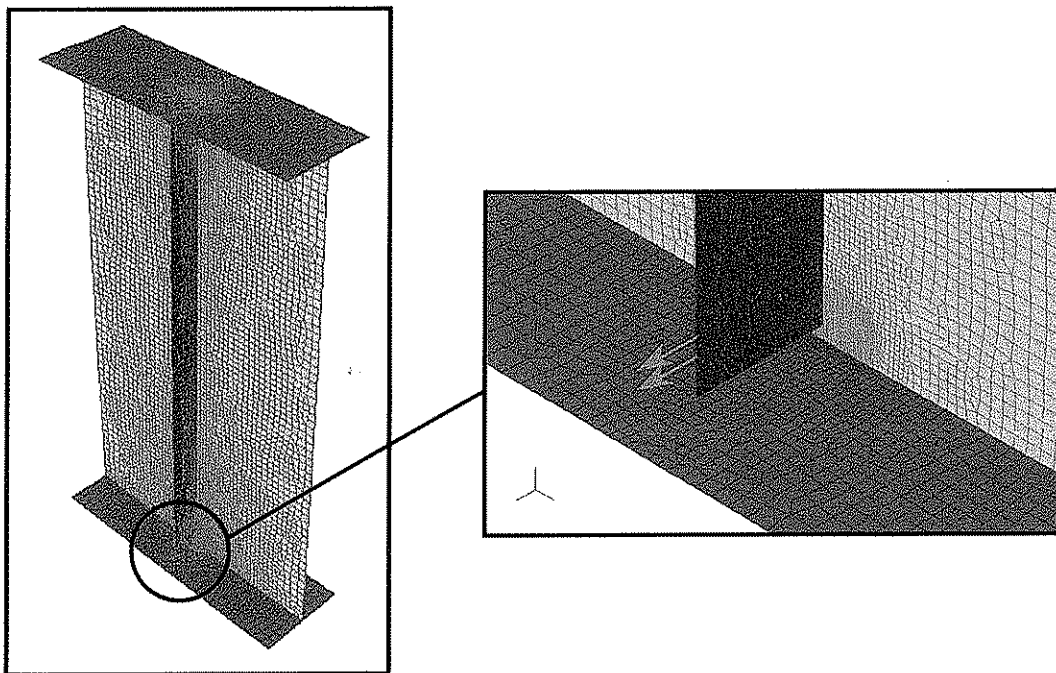
In order to assess the possibility of cracking at the exterior girder, a simplified model was developed using the finite element method. Figure 6.6 is a general view of the model and contains a detailed view at the stiffener and web connection. Although it can not be clearly discerned in Figure 6.6, a very fine mesh was used in the web gap region. All components were modeled using three dimensional plate elements. Hence, the effect of additional constraint provided by the fillet welds is not considered. Nevertheless, the model does provide a reasonable estimate of the magnitude of stresses that could be expected at this detail.

Using the measurements made during the on-site monitoring of random traffic (a portion of which is shown in Figure 4.4), an estimate of the force applied to the connection was made. This force was then applied to the connection as shown in Figure 6.6. Based on the finite element analysis, stress ranges of 10 ksi to 14 ksi could be expected in the web gap at this detail when subjected to the 3.6 kip force in the lateral strut. The calculated out-of-plane displacement is only 0.0018 inches. Note the displacement measured at FB37 (see Table 4.4) showed that a movement of 0.0007 in resulted in a stress range of 6.3 ksi during passage of the test truck.

Figure 6.6 – Finite element models used to estimate stress range at bottom web gap at floorbeam FB24 on girder G1

Channel CH_27 was not included in the long-term monitoring program. Hence, a stress range histogram must be estimated using data from channel CH_21. Channel CH_21, mounted on the gusset plate near G2 (See Drawing 3 in Appendix A) was included in the long-term monitoring program. The data from this channel can be used to make reasonable estimates of the variable amplitude stress range spectrum at CH_27 and CH_22. Based on a comparison of the data collected during the controlled load tests and the on-site monitoring, the maximum stress range that could be expected at channel CH_27 is about 1/4 to 1/3 of the measured stress range at channel CH_21 (see Figure 6.4). The long-term monitoring program indicated that the peak stress range at channel CH_21 was about 5.25ksi. This corresponds to a stress range at channel CH_27 of about 1.75ksi and estimated force of 8.5 kips in the WT 5 x 16.5. This is about 2.2 times greater than measured during the on-site monitoring program. These upper bound values result in out-of-plane stresses of 22ksi to 30ksi in the web gap. An estimate of the number of cycles greater than the CAFL based on the cycle frequency provided in Table 5.7 indicates that cracking resulting from out-of-plane forces could be expected at this type of detail.

Cracks have been observed at similar details in span 10 (e.g., G4 FB22, G1, FB16) [3]. These cracks have been observed to grow through the weld throat and not at the weld toe, which is characteristic of smaller web gaps. The measurements and the finite element model reasonably predict the potential for cracking at this type of detail.

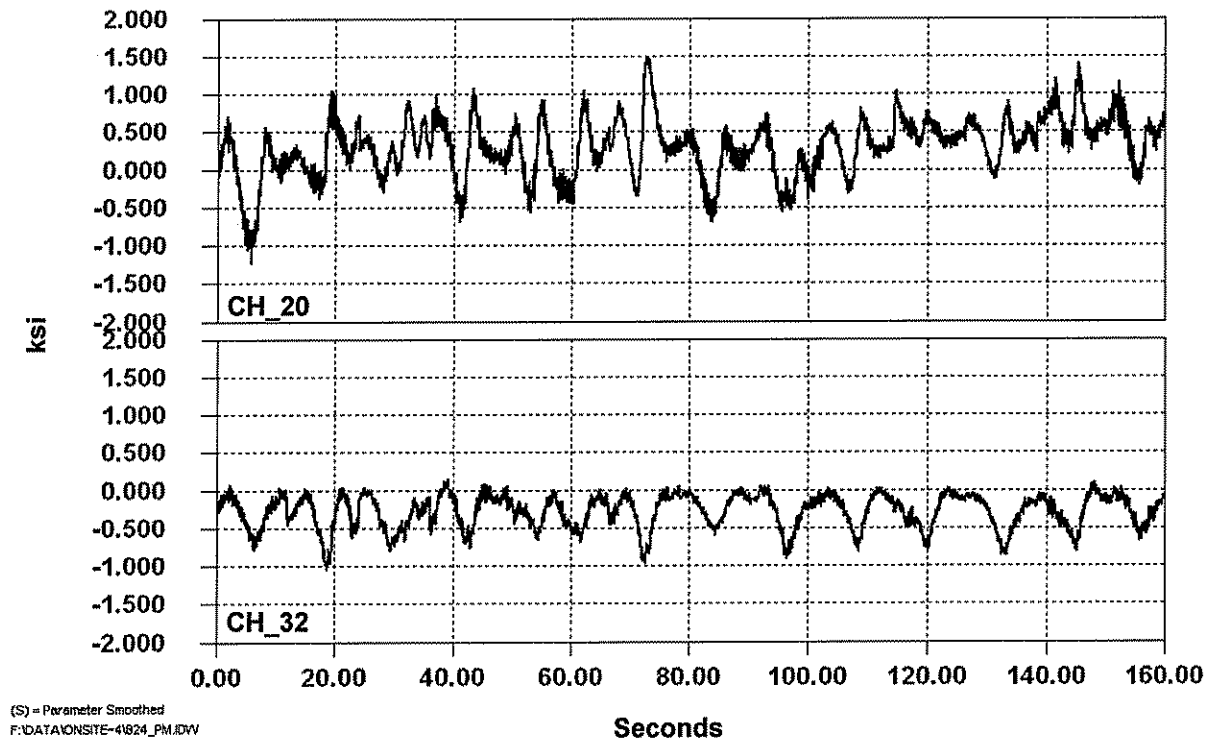
Only limited test data were obtained at FB24 for the bottom connection plate web gap at girder G2 at channel CH_32 and on the lateral strut in bay 1 at channel CH_22. No long-term data were collected at channel CH_32 as the test truck and on-site monitoring resulted in very low stresses at this location. Extensive test data were acquired at CH_19, CH_20 and CH_21 which were located on the gusset plates. Figure 6.7 compares data from channels CH_20 and CH_32 that were collected during of the on-site monitoring. Considering the random data collected on-site, it was found the stress

range at channel CH_32 is typically only 50% to 75% of the stress range at channel CH_22. Conservatively using the upper limit of 75%, the data for channel CH_20 found in Table 5.7, an estimate of the maximum and effective stress range was made for channel CH_32. The results are provided in Table 6.3.

Figure 6.7 – Comparison of response at channels CH_20 and CH_32

The results listed in Table 6.3 indicate that web gap cracking at the interior girders would not be expected. Even if the maximum stress is doubled, the maximum stress range is only 9.8 ksi, which is less than the CAFL of the detail. This is compatible with the behavior as no cracking has been observed in Span 10 at any of the bottom web gaps at the interior girders.

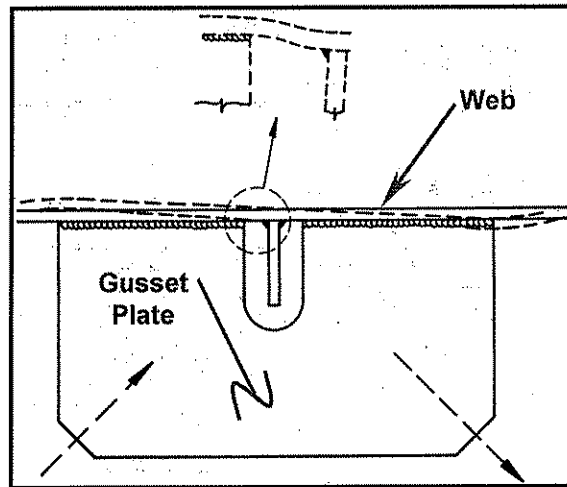
Measurements have revealed that at side span locations where the gusset plate is welded to the web but not directly attached to the transverse connection plates on either side of the web are the most critical details on the Kanawha River Bridge. Out-of-plane distortion in the web gap region occurs between the transverse connection plate and gusset plate as shown exaggerated in Figure 6.6. Although the displacement is very small, it is concentrated over a very short web gap length, as shown in Figure 6.9.

Figure 6.9 - Out of plane displacements at web gaps between transverse connection plates and gusset plates

In order to provide sufficient restraint, it is suggested that the existing angles be removed and replaced with heavier angles or a 1 inch thick plate. The thickness of the angles should be a minimum of $\frac{3}{4}$ ". If the angles are limited to the two bolt connections between the outstanding angle legs and the transverse connection plate and the gusset plate,

supplemental welds should be added to the exposed edges of the angle legs and the transverse connection plate and the lateral gusset plates. Alternatively, 1 inch thick plates could be used to replace the 3/8 inch angle segments. A 3/4 inch bevel could be fabricated on one edge that would be fitted against the transverse connection plate. This would allow a partial penetration groove weld to be installed between the 1 inch plates and the transverse connection plate. The plates could be held in place with bolts installed in the gusset plate while the weld was made. Then, 1/2 inch fillet welds could be placed along two edges of the 1 inch plate and the gusset plate surface. All welding would be down hand which should improve the quality. There will be no adverse affects of field welding to the transverse connection plate and gusset plate as the cyclic stress in those elements are low. Appropriate surface preparation and welding techniques should be employed. The lower end of the knee brace and the ends of the diagonals framing into the gusset plate can be trimmed as required. This would allow four bolt connections in the angle legs.
